**Appendix B**  
**Flood Event Photos**

# Appendix B – Photos of Flooded Areas in Truckee River Downtown

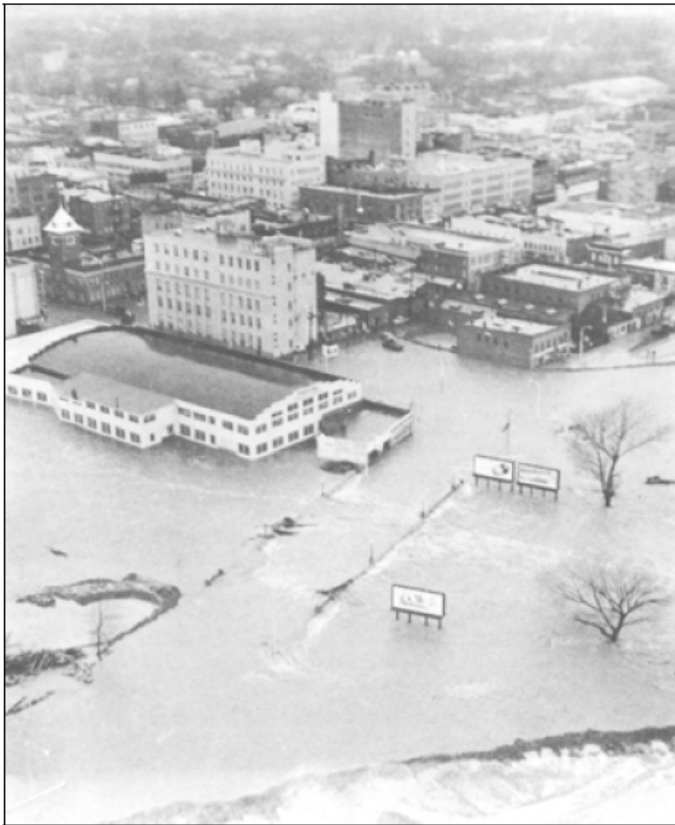
### Flood Event on December 23, 1955 (flow rate = 20,800 cfs)

Looking Northwest at Lake Street in Foreground

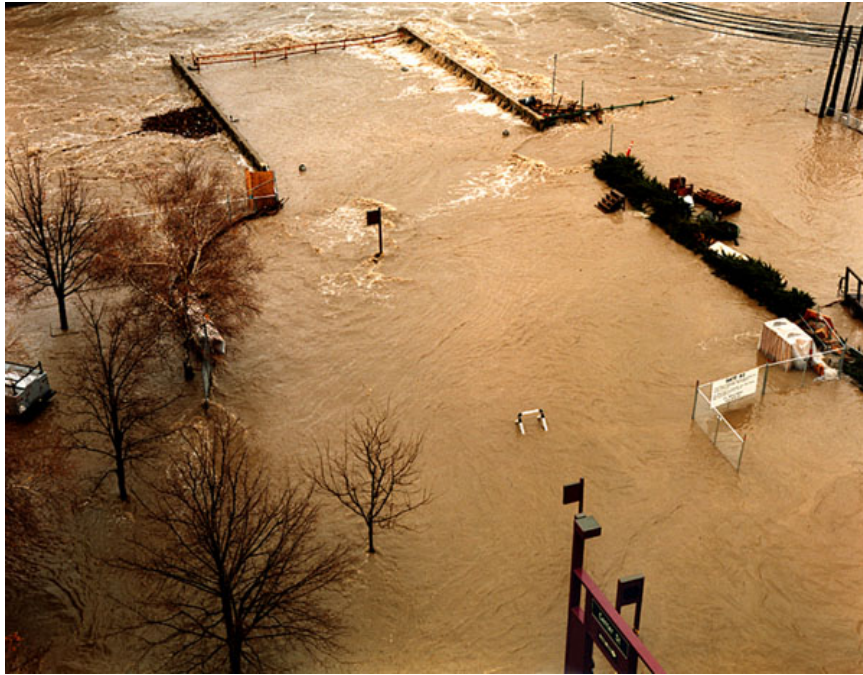
## Flood Event on January 2, 1997 (flow rate = 18,200 cfs)

At Center Bridge:

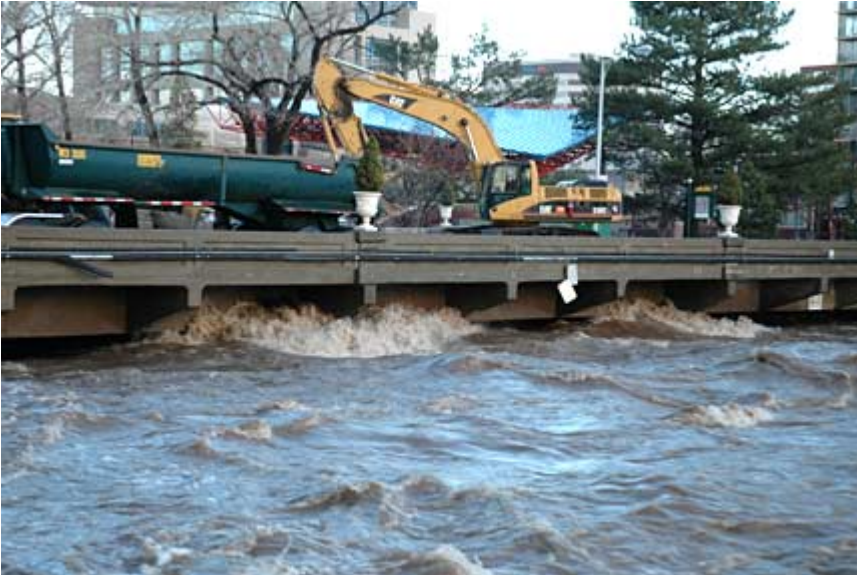
**Flood Event on December 31, 2005 (flow rate = 16,400 cfs)**

Looking east (downstream) at north Arlington Ave.

The 2005 flood event was used for model calibration since the most photos were taken and are available for this event. The high water surface elevation was estimated by viewing the photos and approximating depth relative to the low chord of the bridge. Photos from the 1955 and 1997 floods are included in this Appendix for reference.

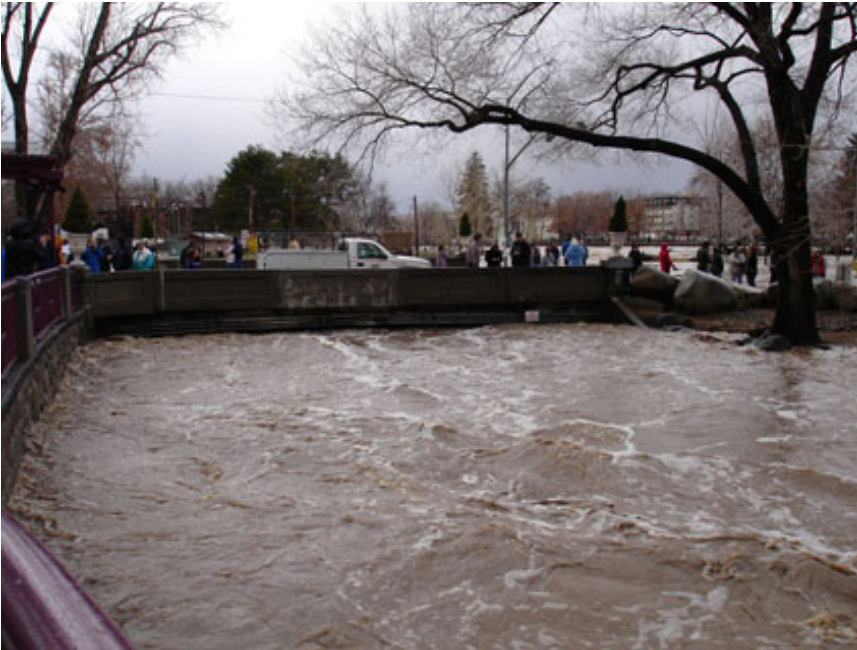
Looking West at the South Arlington Bridge

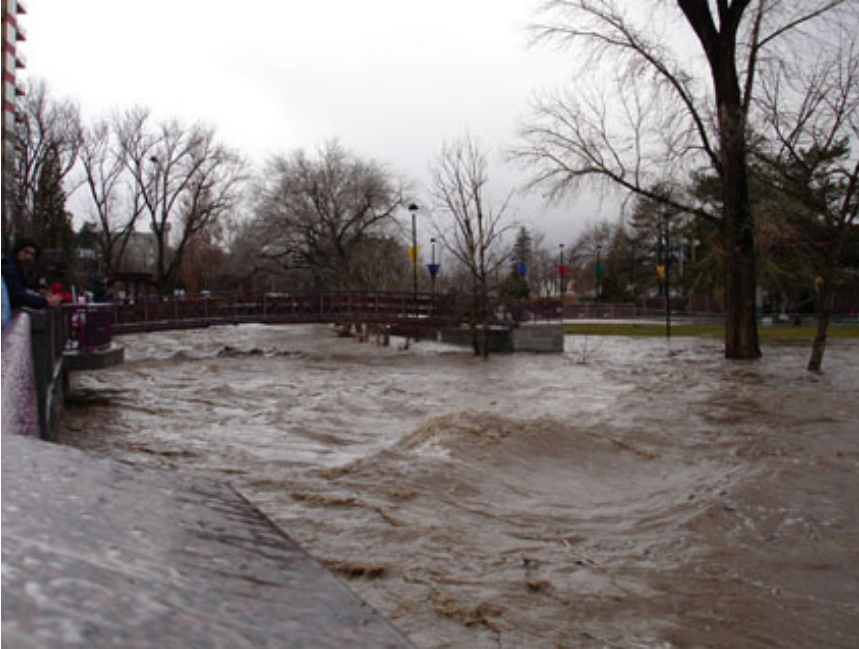
Looking West at Wingfield Park from Southside of River

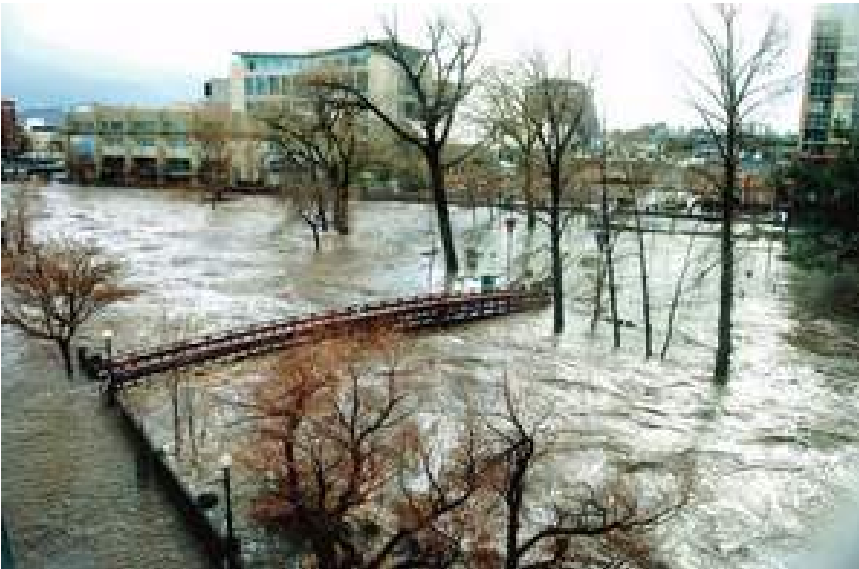
Looking Southeast Wingfield Park

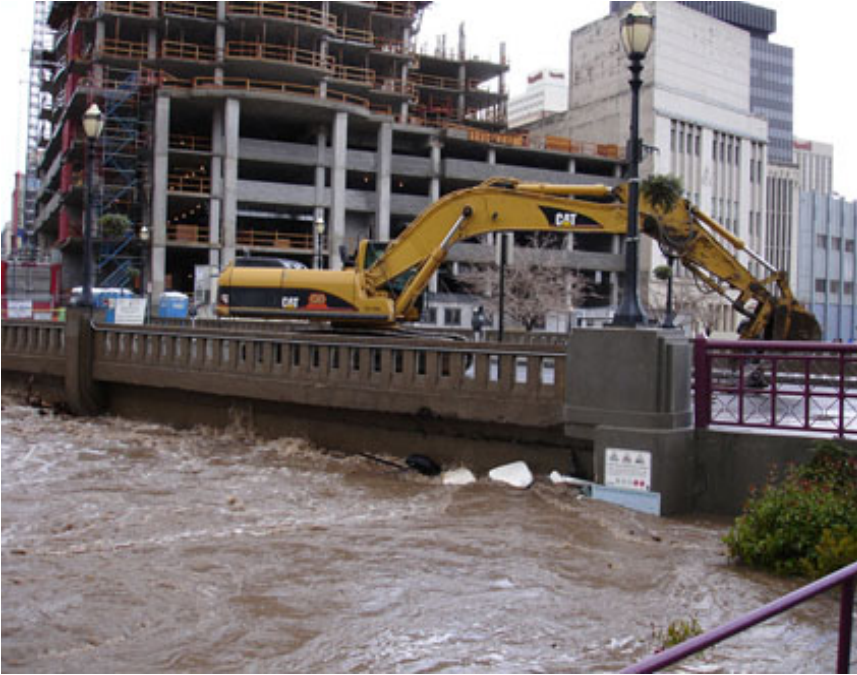
Looking Northeast at upstream side of Sierra

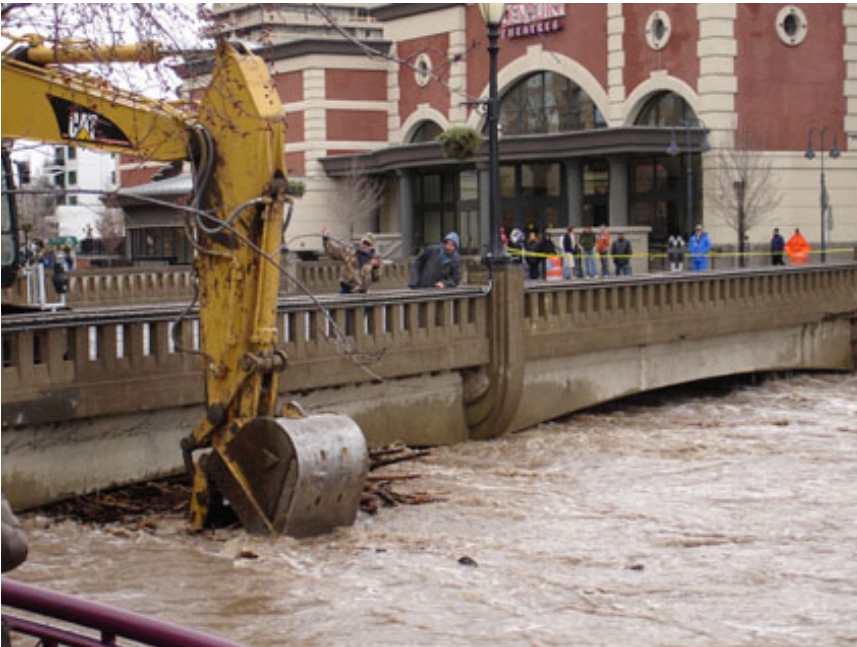
Looking upstream at South Span of Sierra Street

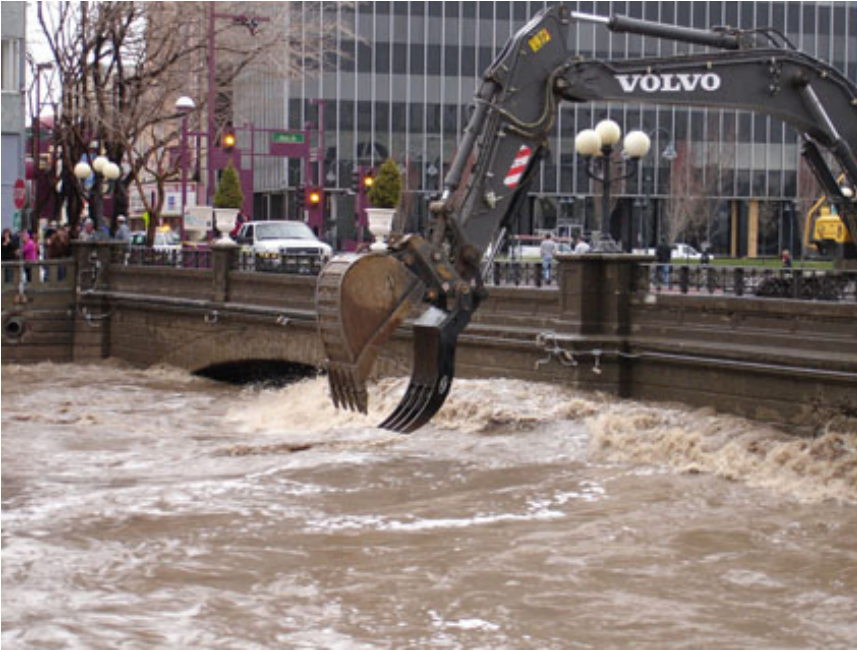
Looking at upstream side of Virginia Street

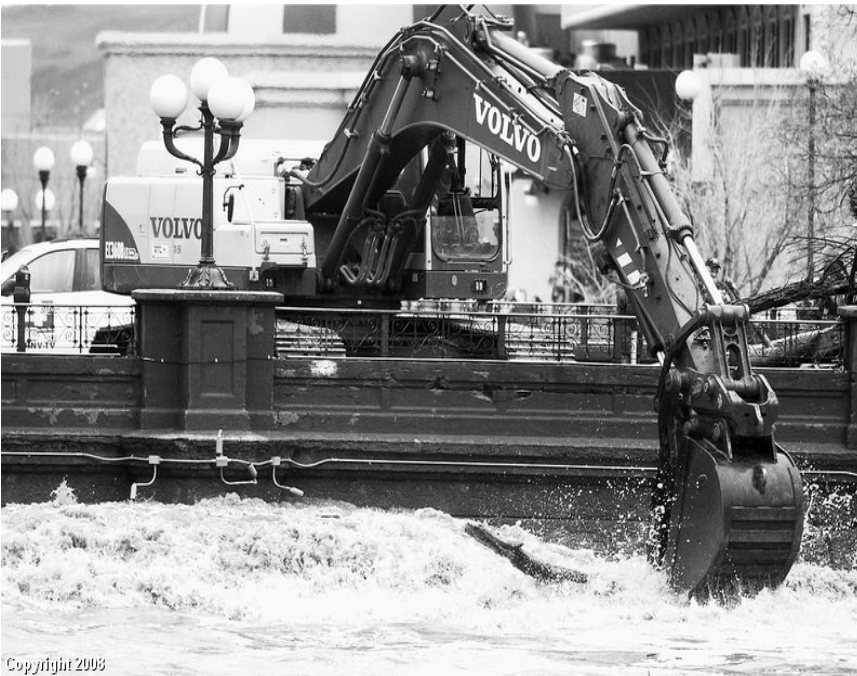
Looking at upstream side of Virginia Street

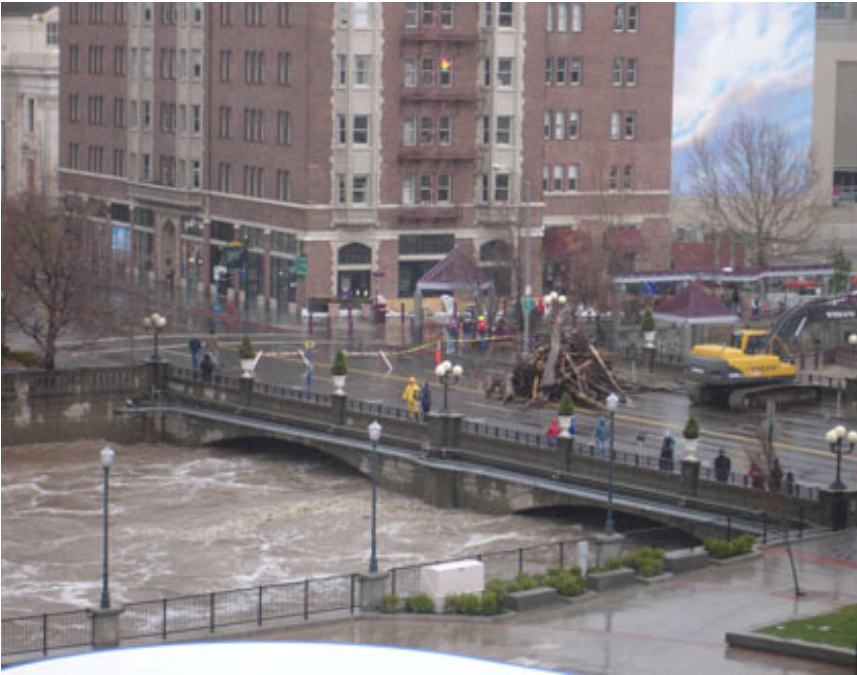
Looking Southwest (at downstream side) at Virginia Street from Cal Neva Garage

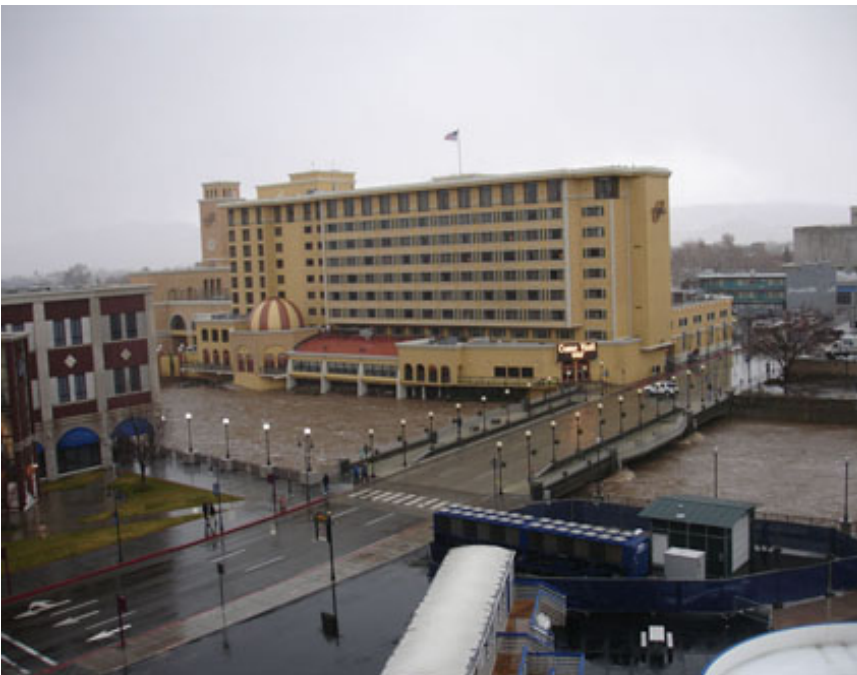
Looking Southeast at Sienna Hotel from Cal Neva Garage

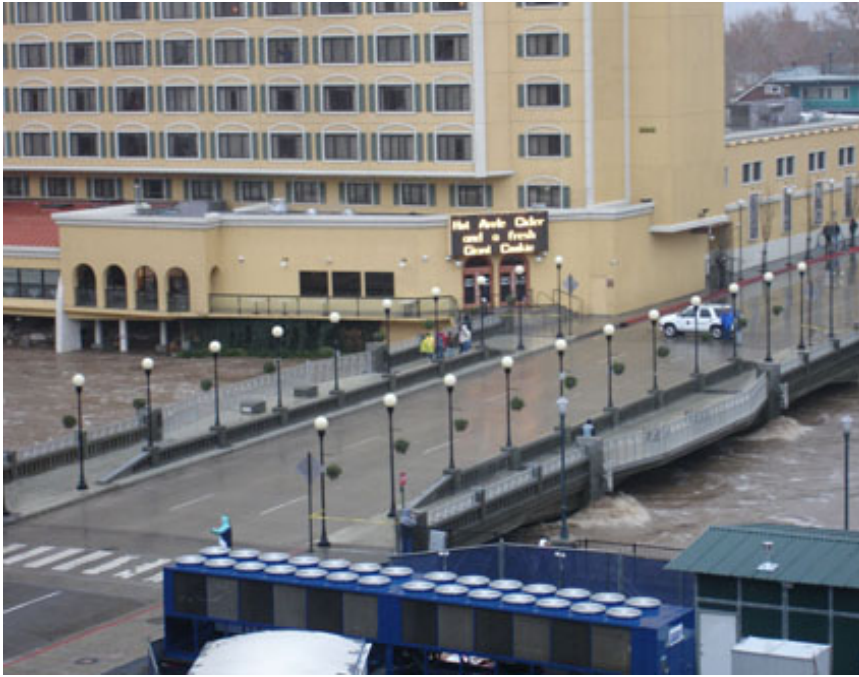
Looking Southeast (upstream side) Center Street from Cal Neva Garage
